*23rd World Gas Conference, Amsterdam 2006*

**FIELD TEST OF HYDROGEN IN THE NATURAL GAS GRID**

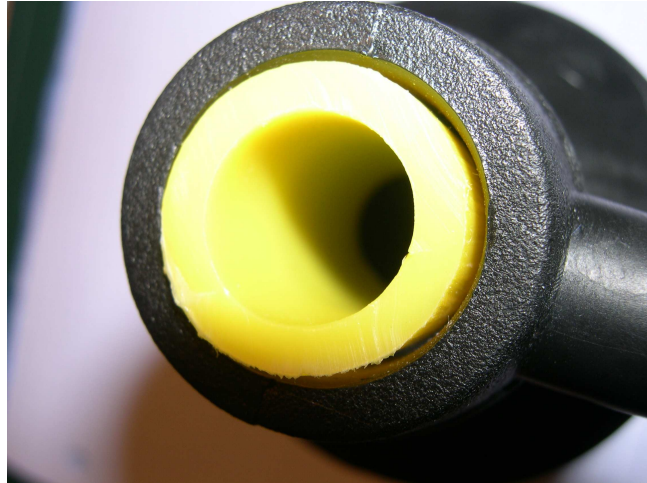
Leaks were detected upon start-up after hydrogen filling; otherwise only at months' interval. However, a slight leakage from one of the gas meters was detected throughout the entire test period.

Figure 5: The photo shows a plastic transition joint frequently used in the Danish gas grid. During the tests, this piece connects the supply pipes with the test pipes. At start-up, more than half of these pieces leaked hydrogen and had to be replaced; the reason being a too large clearance between connecting pipe and transition piece.

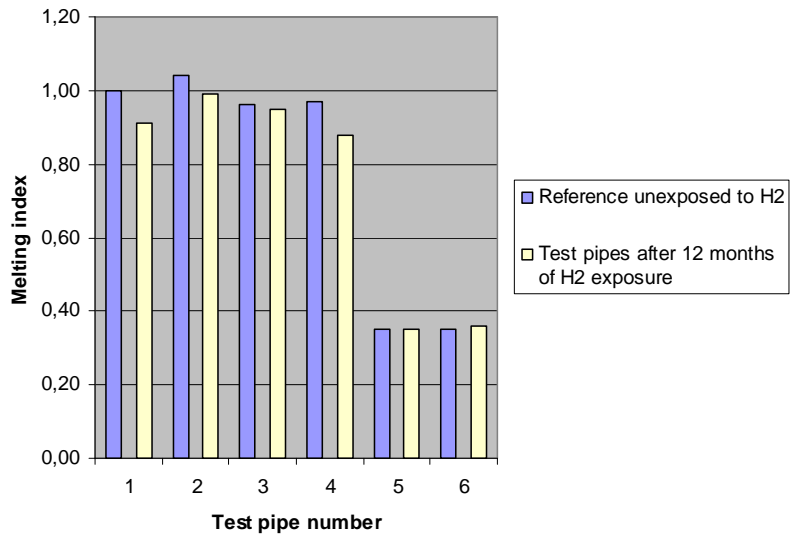
- Practical welding tests have proven an unchanged weldability.
- The melting index for three out of four hydrogen exposed PE80 pipes dropped by 5-10%. This could indicate incipient changes to the material. No changes were found in the PE100 samples (tube number 5 and 6 at Figure 6) after the hydrogen exposure.

Figure 6: Melting index test according to ISO 1133.

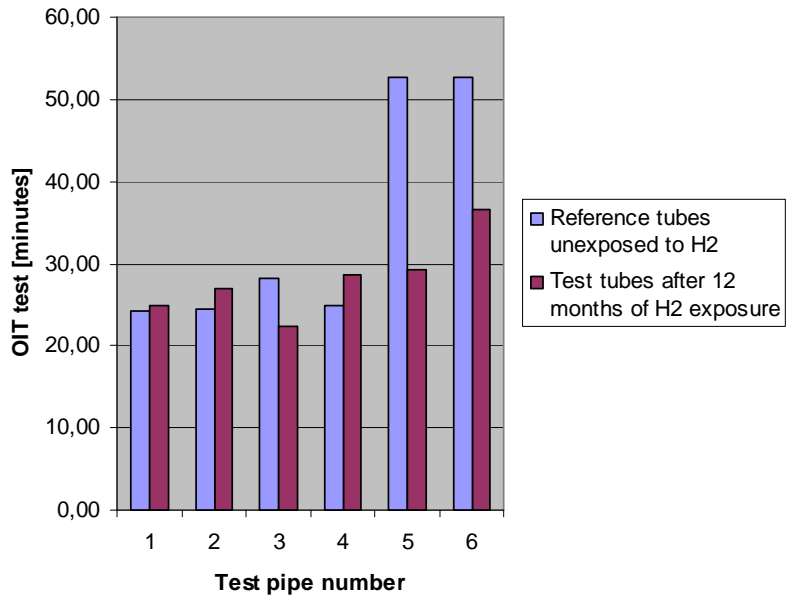
- OIT (oxygen induction) tests showed that the efficiency of the added antioxidant was reduced and that a few years of continued hydrogen exposure could reduce weldability to an unacceptable level for high-strength PE100 pipes. See Figure 7.

Figure 7: Oxygen induction test according to DS 2131.

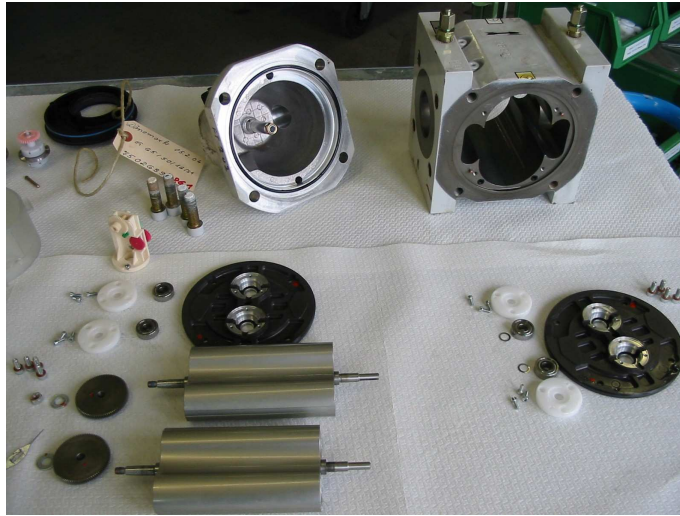
Figure 8: Rotational type industrial gas flowmeter dismantled before inspection for damages at the manufacturer (Elster)

Industrial gas meters and the domestic gas meter were not damaged by the test operation.

- Recalibration at the manufacturer's test bench has shown that all meters complied with specifications.
- Detailed investigations of sensitive components such as rubber gaskets etc. show no signs of abnormal wear or incipient decomposition.
- During the test period a constant minor leak from the turbine gas meter was detected. The above detailed investigations showed no defects in the leaking components. I.e. a change of design is necessary when converting to hydrogen.
- The oil in the rotary gas meter was analyzed after 12 months of exposure to hydrogen. After 12 months the oil still complied fully with the specification. No indication of deterioration was detected.

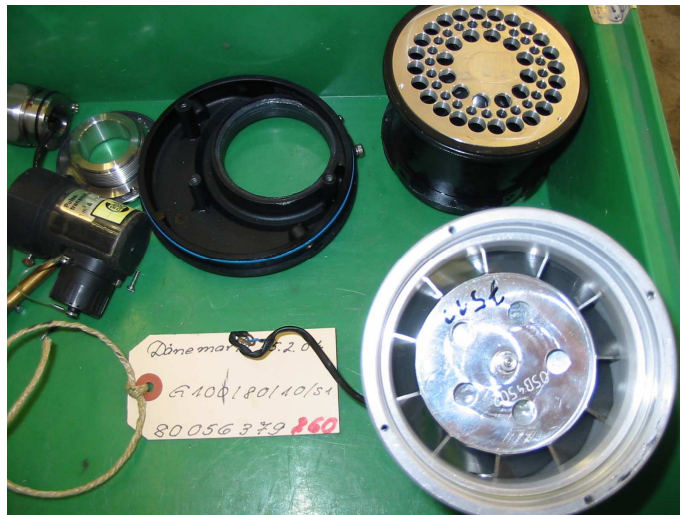
Figure 9: Turbine type gas flowmeter dismantled before inspection and recalibration at the manufacturer (Elster)
