*23rd World Gas Conference, Amsterdam 2006*

**FIELD TEST OF HYDROGEN IN THE NATURAL GAS GRID**

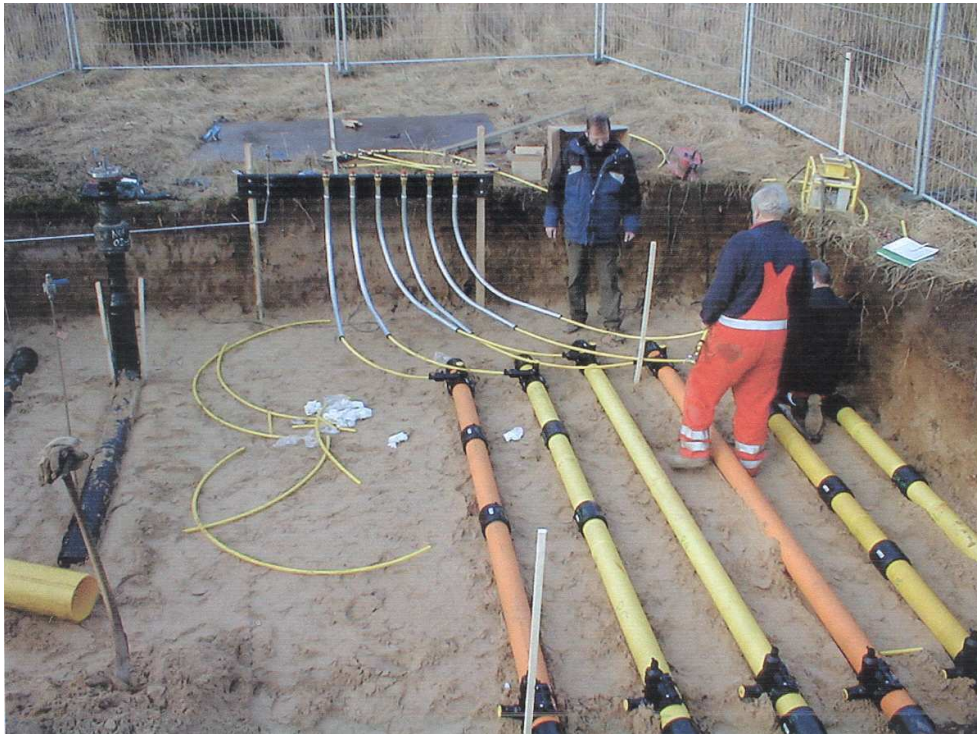
Figure 1: The photo shows laying of the test pipes. The two black pipes to the left are 19 bar steel distribution pipes. The other pipes are new and second-hand pipes from the Danish and Swedish gas grid.

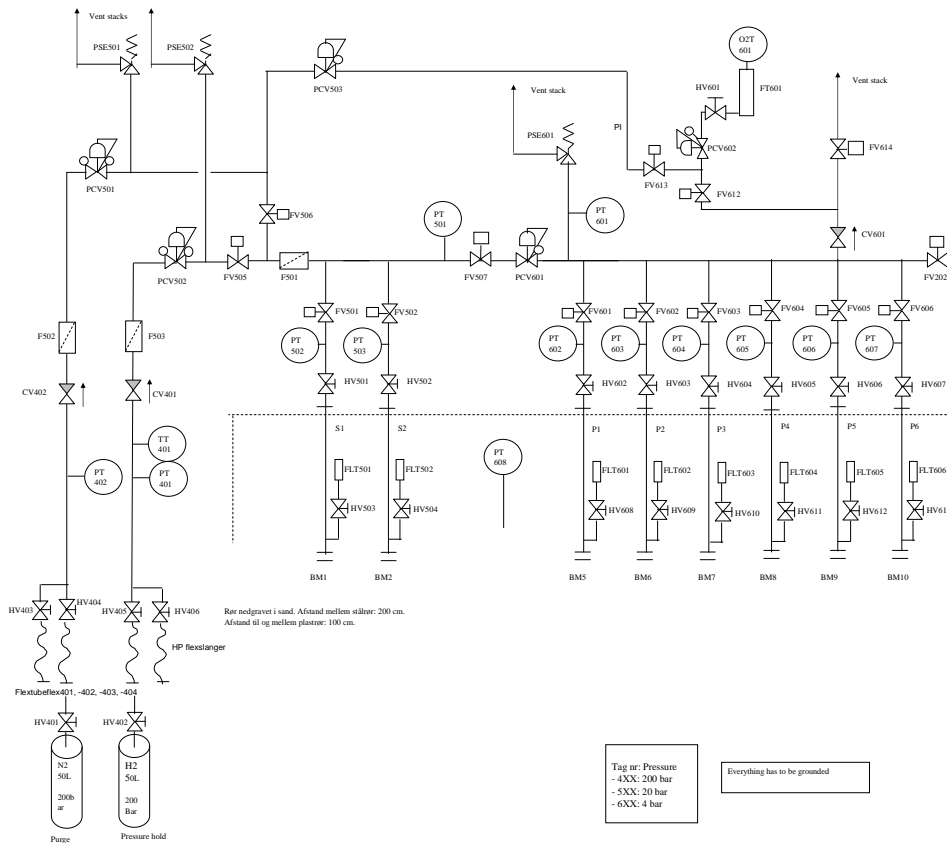
Figure 2: The scheme shows the test rig for testing steel and polymer pipes. All pipes are kept within the normal operational pressure range. 4 bar for polymer and 19 bar for steel distribution.

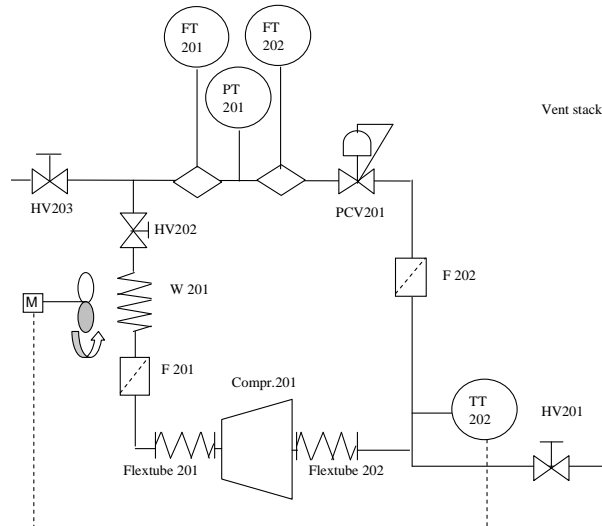
Figure 3: The diagram above shows the test cycle for the two industrial flowmeters for 4 bar pressure level.

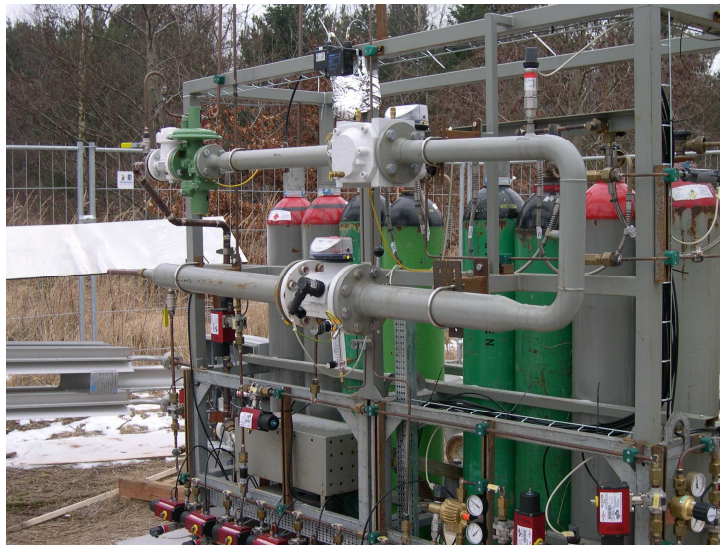
Figure 4: The actual construction of the test cycle for the industrial gas flowmeters. The compressor is situated in the grey box at the left bottom of the picture.
